Getting to know our network - A303 River Avon Bridge Bearing Replacement

The bridge carrying the A303 over the River Avon near Amesbury is supported on 44 nr bearings. The Pot bearings on the westside were in a particularly poor condition. The contract being undertaken by CRL is to replace these bearings on a SSSI site.

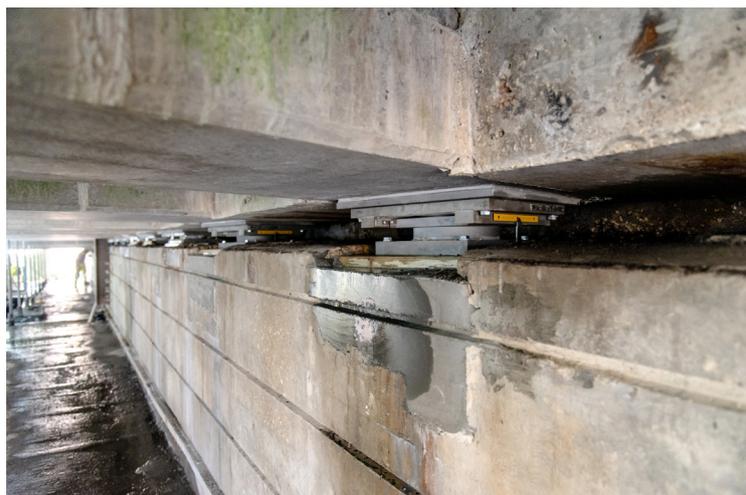
To provide access to the bearing shelves TR scaffold designed and erected scaffolds from the walkway on the East side and hung from the bridge over the river on the west.

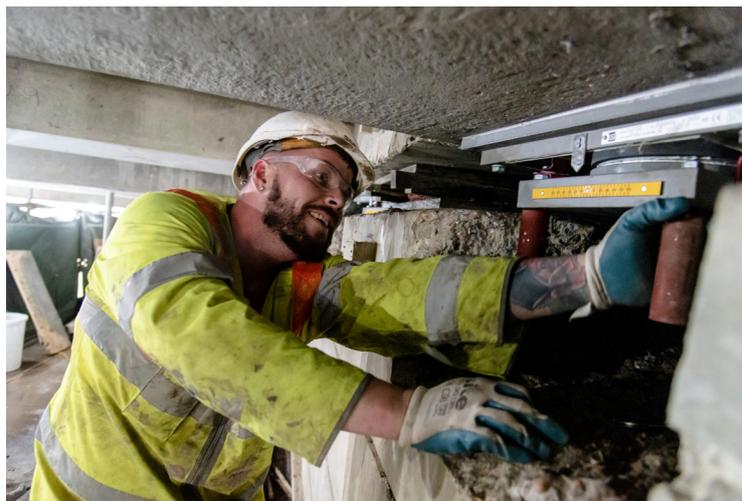
Initially CRL strengthened the structure to allow the bridge to be lifted. This involved infilling the service trenches that passed over the abutments to support the diaphragm sections.

Hydrodemolition was used to break out to enable new rebar to be installed before recasting the section in 4 corners of the bridge.

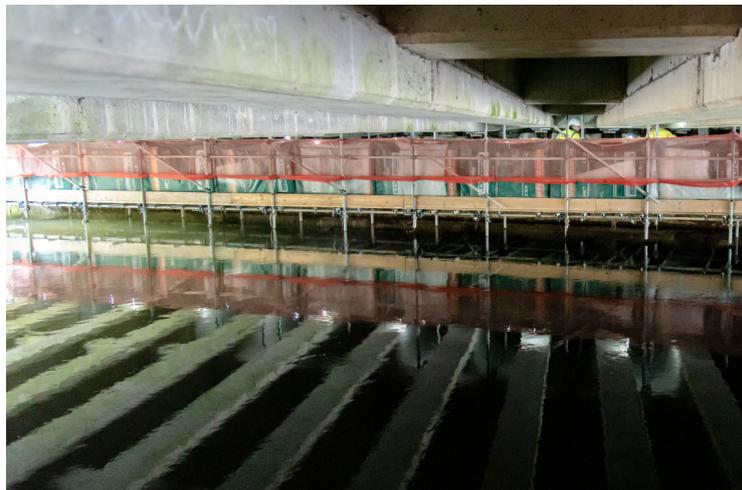
Following completion of a design and approved AIP jacks were installed either side of the bearings. With only a 20mm gap on the east side 60mm of the bearing shelf needed to be removed to allow the jacks to be installed without affecting the existing bearing supports.

The bridge was jacked approximately 2mm under TM closures effected by Forest. Kiers monitored the forces within the structure and that differential movement between beams remained below 0.25mm. Monitoring was carried out using LVDT gauges attached to the control unit that also recorded the hydraulic forces within the jacks.

Dowels through the elastomeric bearings needed to be replaced before these bearings were fixed in position, whilst maintaining freedom to the dowels. Flowable concrete and EP grout were then used to cast in the base of new bearings.

On the west side taper plates were initially fixed that had been manufactured to pick up the inserts within the existing top plate. The main bearings were then bolted onto the levelled plates. The concrete and grout were then cast in place the bottom of the bearing.

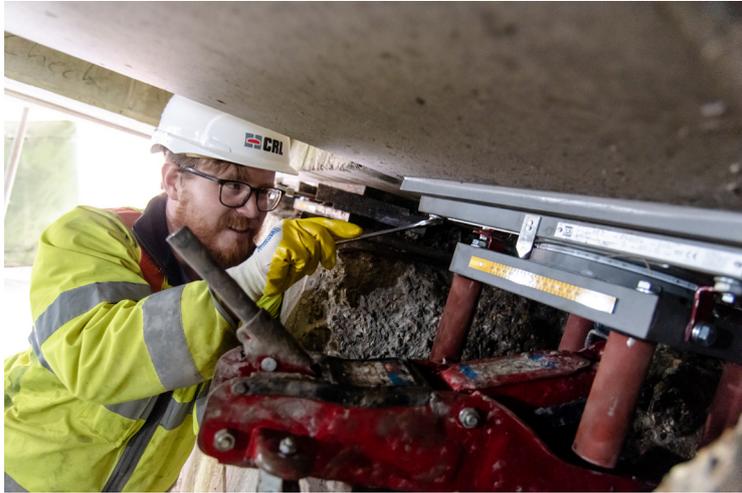
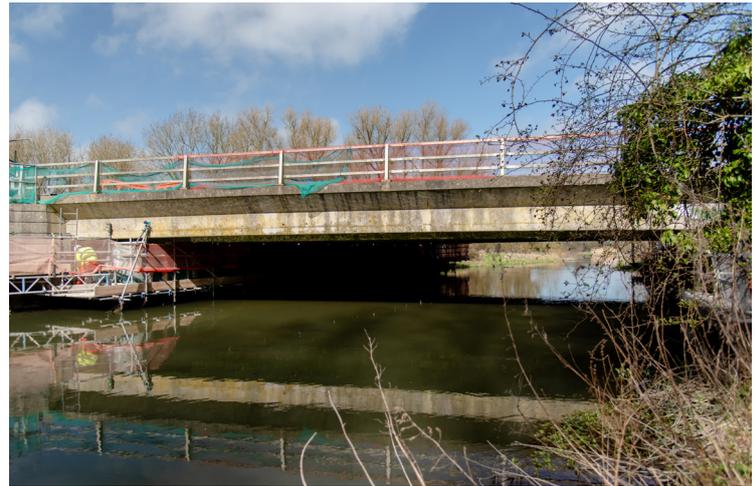
Following checking of the strength of these materials the bridge has been de-jacked on the north side with the gauges indicating the differential displacement between 0.25mm has been maintained.

asphaltic plugs installed by Volker Laser. Concrete Repairs and anti-graffiti coating to the walkway abutment will complete the refurbishment to this bridge without adversely affecting the SSSI site.

Following de-jacking of the South side the top 50mm of HRA over the bridge will be replaced by FM Conway and new
